**Flood Control Project Maintenance
Levee Inspections**

Maintenance Issue Types Only, Levee Inspection Report By Mile - Spring 2017

Sutter Maintenance Yard East-West Interceptor

Waterway	Bank	Unit Miles	Inspection Start/End	Inspector
Unit No. 01 West Levee	Right	1.75	04/12/2017 04/12/2017	Bob Duffey

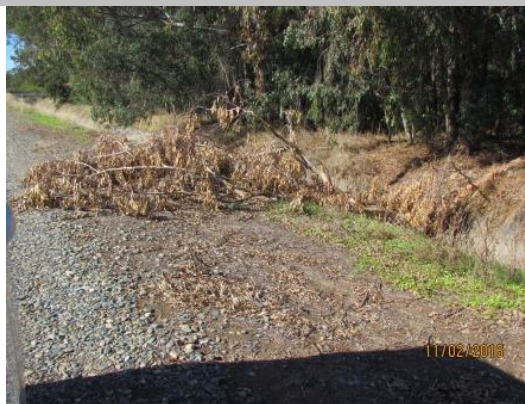
Photo 1 of 1 : SP_2017_ST0020_213_14_20170315_00010.jpg

LM Start	0.43	Rating **	M	Issue No.	14
LM End	0.43	Issue Type +	Ma	Location *	WS
Category	Earthen Levee			GPS Latitude/Longitude	
				Start	End
Item	Encroachments			39.171422 °	39.171422 °
				-121.751978 °	-121.751978 °
DWR ID	DWR_ST0020_01_f_2016_14				
Comment Code					
TR : Tree or limb					
Inspector Comment					
Remove the tree limb from the waterside.

View of a fallen limb.

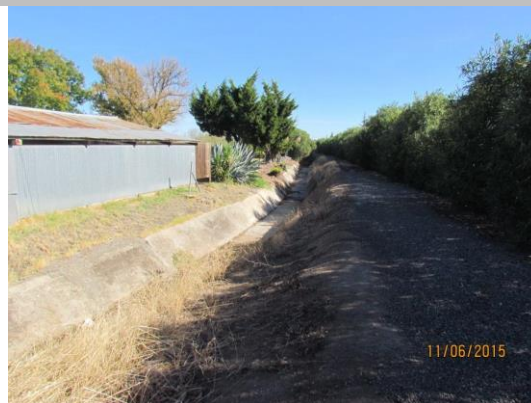
Photo 1 of 2 : SP_2017_ST0020_213_4_20170315_00004.jpg

LM Start	0.62	Rating **	U	Issue No.	4
LM End	0.65	Issue Type +	Ma	Location *	WS
Category	Earthen Levee			GPS Latitude/Longitude	
				Start	End
Item	Erosion / Bank Caving			39.171292 °	39.171232 °
				-121.748868 °	-121.748175 °
DWR ID	DWR_NA0020_01_s_2012_4				
Comment Code					
E2 : Schedule repair of erosion site prior to the next inspection.					
Inspector Comment					
Repair the erosion along the concrete ditch.

View the erosion along the concrete ditch.

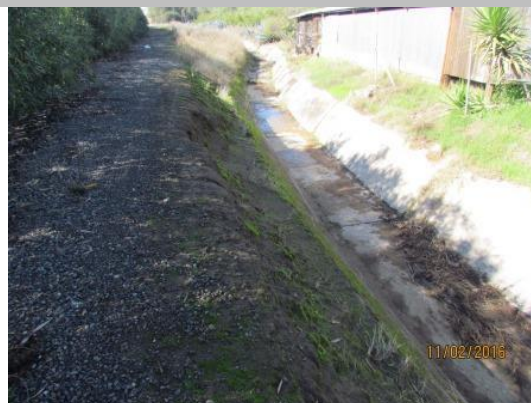
Photo 2 of 2 : SP_2017_ST0020_213_4_20170315_00005.jpg

LM Start	0.62	Rating **	U	Issue No.	4 (cont)
LM End	0.65	Issue Type +	Ma	Location *	WS

Another view the erosion along the concrete ditch.

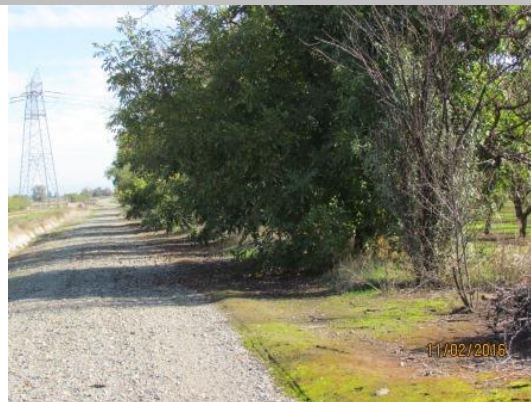
Photo 1 of 1 : SP_2017_ST0020_213_18_20170315_00014.jpg

LM Start	1.11	Rating **	M	Issue No.	18
LM End	1.28	Issue Type +	Ma	Location *	LS
Category	Earthen Levee			GPS Latitude/Longitude	
				Start	End
Item	Trim / Thin Trees			39.171283 °	39.171243 °
				-121.739315 °	-121.736312 °
DWR ID	DWR_ST0020_01_f_2016_18				
Comment Code					
T1 : Trim trees to at least five feet above ground level.					
Inspector Comment

View of the trees blocking visibility.

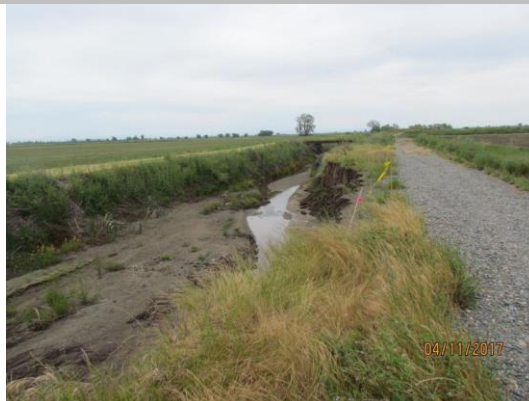
Photo 2 of 2 : SP_2017_ST0020_213_6_20170413_00023.jpg

LM Start	1.65	Rating **	U	Issue No.	6 (cont)	
LM End	1.65	Issue Type +	Ma	Location *	WS	
Category	Rivers, Channels & Designated Floodways			GPS Latitude/Longitude		
				Start		End
Item	Erosion / Bank Caving			39.171132 °		39.171132 °
				-121.729312 °		-121.729312 °
DWR ID	DWR_NA0020_01_s_2012_6					
Comment Code						
Inspector Comment						
Sutter Yard needs to repair the erosion before winter.

Repair the erosion along the waterside slope.

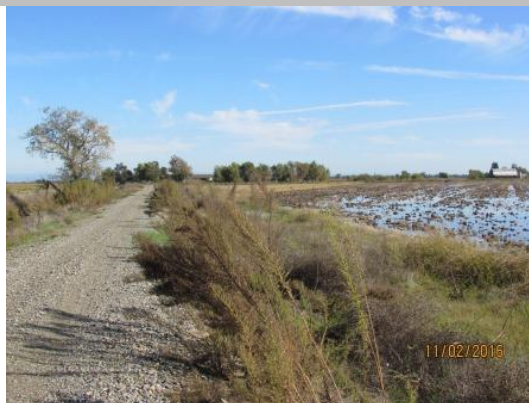
Photo 1 of 1 : SP_2017_ST0020_214_11_20170315_00010.jpg

LM Start	0.00	Rating **	M	Issue No.	11
LM End	0.26	Issue Type +	Ma	Location *	LS
Category	Earthen Levee			GPS Latitude/Longitude	
				Start	End
Item	Vegetation			39.171116°	39.171101°
				-121.726501°	-121.721857°
DWR ID	DWR_NA0020_02_s_2012_11				
Comment Code					
V1 : Control annual grass and weeds on the levee slopes and easements.					
Inspector Comment

View of the annual grass along the landside slope.

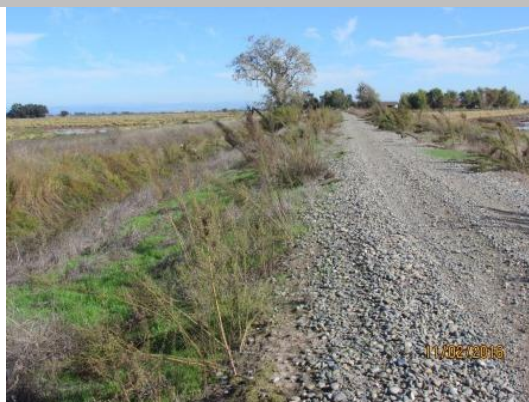
Photo 1 of 1 : SP_2017_ST0020_214_24_20170315_00012.jpg

LM Start	0.03	Rating **	M	Issue No.	24
LM End	0.25	Issue Type +	Ma	Location *	WS
Category	Earthen Levee			GPS Latitude/Longitude	
				Start	End
Item	Vegetation			39.171152 °	39.171160 °
				-121.725937 °	-121.721673 °
DWR ID	DWR_ST0020_02_f_2016_24				
Comment Code					
V1 : Control annual grass and weeds on the levee slopes and easements.					
Inspector Comment

View of the annual grass along the waterside slope.

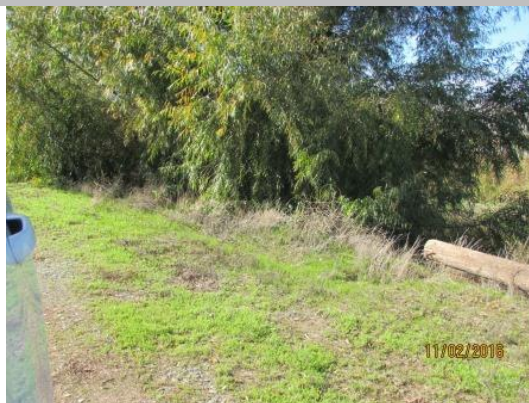
Photo 1 of 1 : SP_2017_ST0020_214_31_20170315_00014.jpg

LM Start	0.29	Rating **	M	Issue No.	31
LM End	0.29	Issue Type +	Ma	Location *	WS
Category	Earthen Levee			GPS Latitude/Longitude	
				Start	End
Item	Trim / Thin Trees			39.171008 °	39.171008 °
				-121.721025 °	-121.721025 °
DWR ID	DWR_ST0020_02_f_2016_31				
Comment Code					
T1 : Trim trees to at least five feet above ground level.					
Inspector Comment

View of the overgrown trees blocking visibility and access.

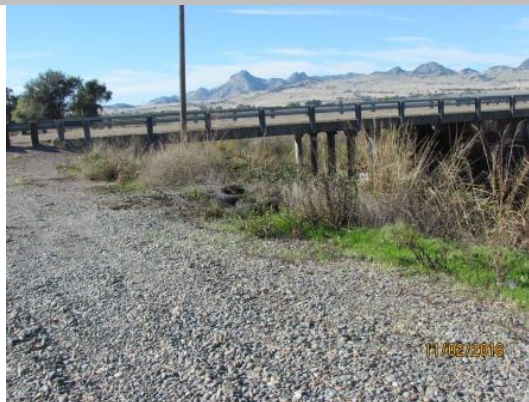
Photo 1 of 1 : SP_2017_ST0020_214_28_20170315_00013.jpg

LM Start	0.53	Rating **	M	Issue No.	28
LM End	0.53	Issue Type +	Ma	Location *	WS
Category	Earthen Levee			GPS Latitude/Longitude	
				Start	End
Item	Encroachments			39.171028 °	39.171028 °
				-121.716475 °	-121.716475 °
DWR ID	DWR_ST0020_02_s_2016_28				
Comment Code					
DE : Debris					
Inspector Comment					
Tires and tree clippings on w/s crown.

View of the tires along the waterside berm.

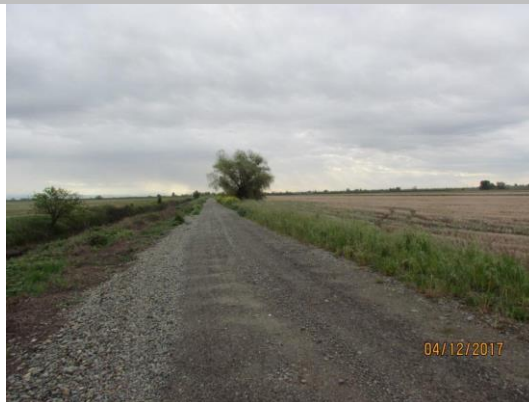
Photo 1 of 2 : SP_2017_ST0020_214_2_20170413_00045.jpg

LM Start	0.55	Rating **	M	Issue No.	2
LM End	1.42	Issue Type +	Ma	Location *	LS
Category	Earthen Levee			GPS Latitude/Longitude	
				Start	End
Item	Vegetation			39.171002 °	39.170770 °
				-121.716293 °	-121.699987 °
DWR ID	DWR_NA0020_02_s_2012_2				
Comment Code					
V1 : Control annual grass and weeds on the levee slopes and easements.					
Inspector Comment					
Remove the vegetation from landside slopes.

View of the vegetation on landside slope.

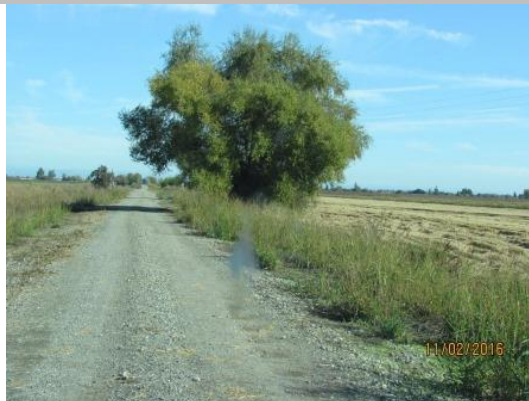
Photo 2 of 2 : SP_2017_ST0020_214_2_20170315_00001.jpg

LM Start	0.55	Rating **	M	Issue No.	2 (cont)	
LM End	1.42	Issue Type +	Ma	Location *	LS	
Category	Earthen Levee			GPS Latitude/Longitude		
				Start		End
Item	Vegetation			39.171002 °		39.170770 °
				-121.716293 °		-121.699987 °
DWR ID	DWR_NA0020_02_s _ 2012_2					
Comment Code						
V1 : Control annual grass and weeds on the levee slopes and easements.						
Inspector Comment						
Remove the vegetation from landside slopes.

View of the vegetation on both slopes.

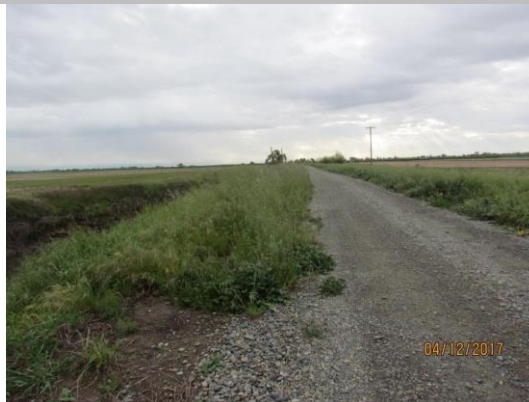
Photo 1 of 1 : SP_2017_ST0020_214_22_20170413_00046.jpg

LM Start	0.68	Rating **	M	Issue No.	22
LM End	1.50	Issue Type +	Ma	Location *	WS
Category	Earthen Levee			GPS Latitude/Longitude	
				Start	End
Item	Vegetation			39.170967 °	39.170458 °
				-121.713828 °	-121.698500 °
DWR ID	DWR_ST0020_02_s _ 2017_22				
Comment Code					
V1 : Control annual grass and weeds on the levee slopes and easements.					
Inspector Comment					
Remove the vegetation from the waterside slope.

View of the vegetation on the waterside slope.

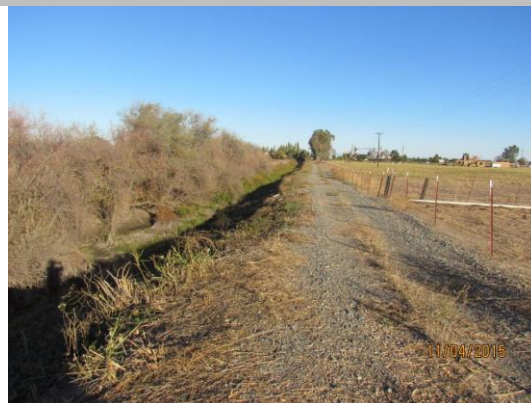
Photo 2 of 2 : SP_2017_ST0020_214_4_20170315_00005.jpg

LM Start	1.54	Rating **	M	Issue No.	4 (cont)	
LM End	2.01	Issue Type +	Ma	Location *	WS	
Category	Earthen Levee			GPS Latitude/Longitude		
				Start		End
Item	Erosion / Bank Caving			39.170800 °		39.170732 °
				-121.698105 °		-121.689082 °
DWR ID	DWR_NA0020_02_s_2012_4					
Comment Code						
E1 : Note and monitor erosion site.						
Inspector Comment						
Monitor the erosion along the waterside slope.

View of the erosion along the waterside slope.

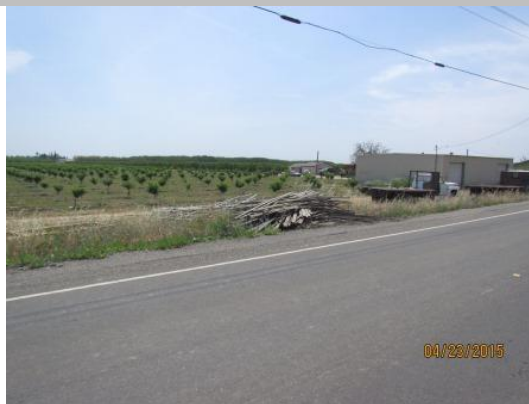
Photo 1 of 1 : SP_2017_ST0020_214_10_20170315_00009.jpg

LM Start	2.71	Rating **	M	Issue No.	10
LM End	2.71	Issue Type +	Ma	Location *	LS
Category	Earthen Levee			GPS Latitude/Longitude	
				Start	End
Item	Encroachments			39.170548 °	39.170548 °
				-121.675970 °	-121.675970 °
DWR ID	DWR_NA0020_02_s_2012_10				
Comment Code					
MA : Material					
Inspector Comment					
Remove the lumber, garbage and equipment from the landside toe.

View of the material, garbage, and equipment along the landside toe
